**How to prolong the life of the railway
coupler system and make it safe up to
the next overhaul period?**

*InnoTrans
PREVIEW*

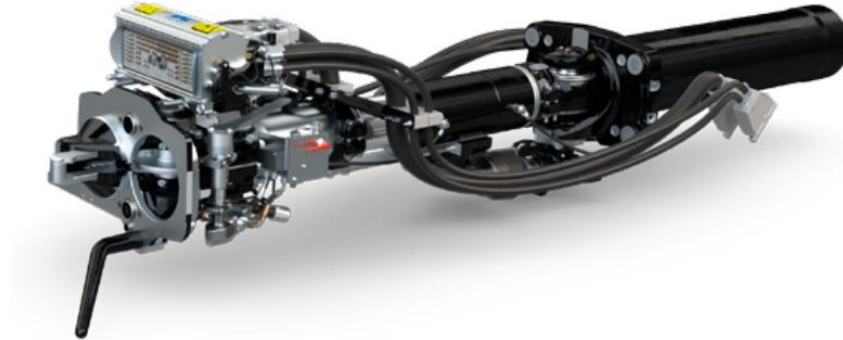
Automatic Coupler

- Automatic couplers
- Foldable Albert couplers
- Data Transmission Products
- Adapters
- Coupler Protection Products
- Dampers
- Crash Energy Management

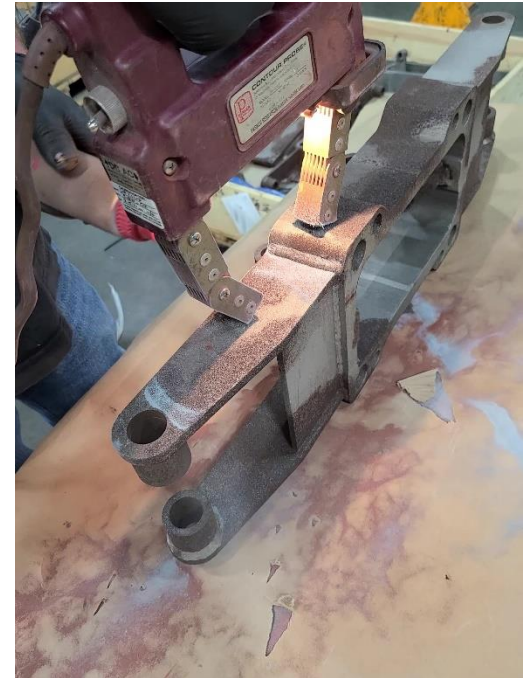
NDT

- Non-destructive testing is recommended to be performed as part of the condition assessment on the main load carrying components of the coupler.
- First the paint is stripped, and then mag-particle testing is used for ferrous parts, and liquid penetrant testing for non-ferrous parts.
- Checking for linear indications indicative of any cracks.
- Cracks are not common, but it is relatively inexpensive to perform and puts passenger safety first.

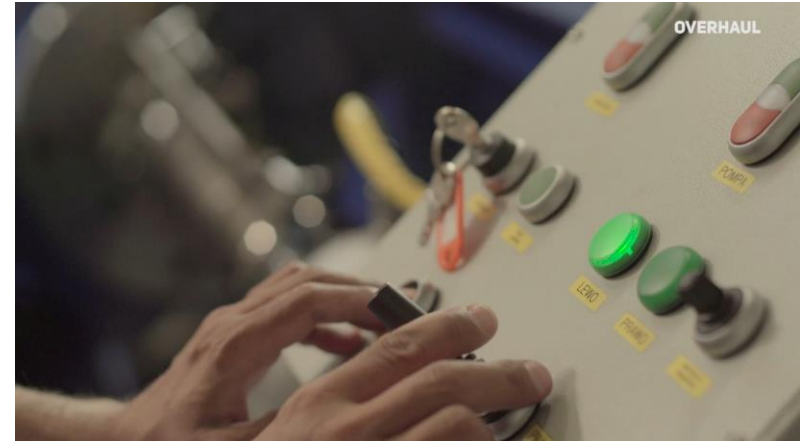
Functional Testing

Subassemblies with specific functional requirements would be tested if applicable:

- Pneumatic cylinders for electrical coupler actuation or automatic uncoupling.
- Electrical linear motors for the same functions.
- Valves, electrical heaters, etc.
- Regenerative crash energy management systems tested to ensure compliance.
